## **Report on the Conn-Weld March 5, 2012 Dust Collector Fire and Deflagration and Associated Litigation**

## Introduction

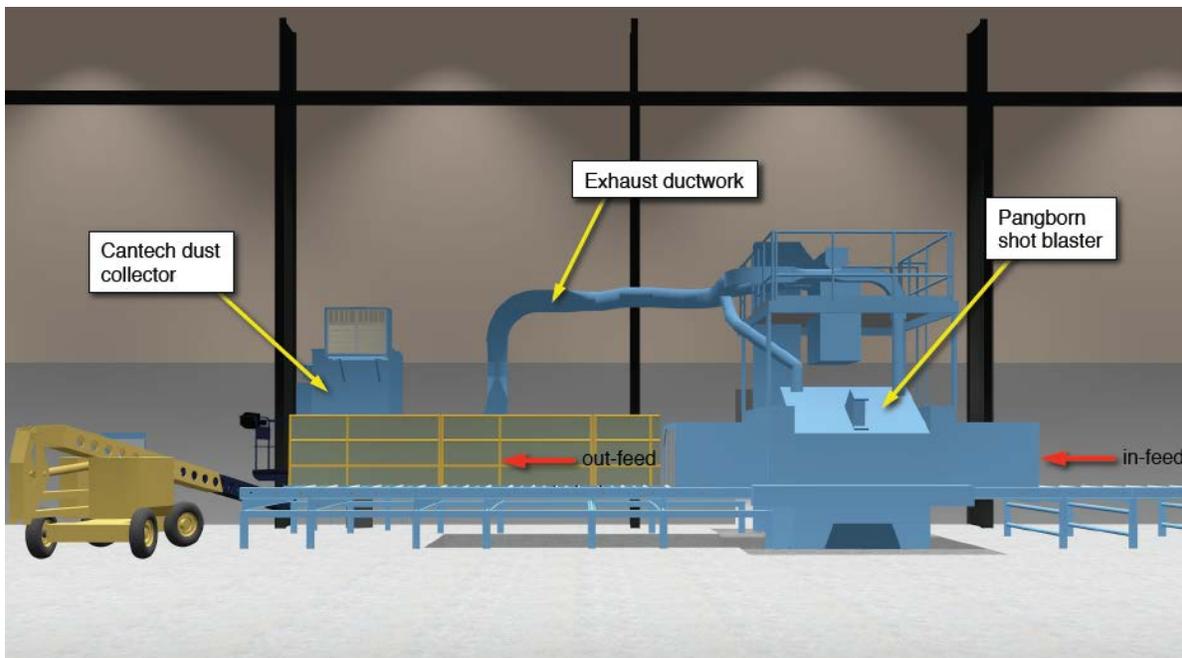
The Conn-Weld equipment pertinent to the March 5, 2012 incident are the Pangborn shot blaster and Cann Tech dust collector and ducting between these two items. The layout of this equipment in Bay 6 of the Conn-Weld plant is shown in Figure 1, which also shows the man lift brought into this area upon discovery of smoke.

Figure 1. Pangborn shot blaster, roll conveyor, dust collector, and ducting, and Grove manlift.

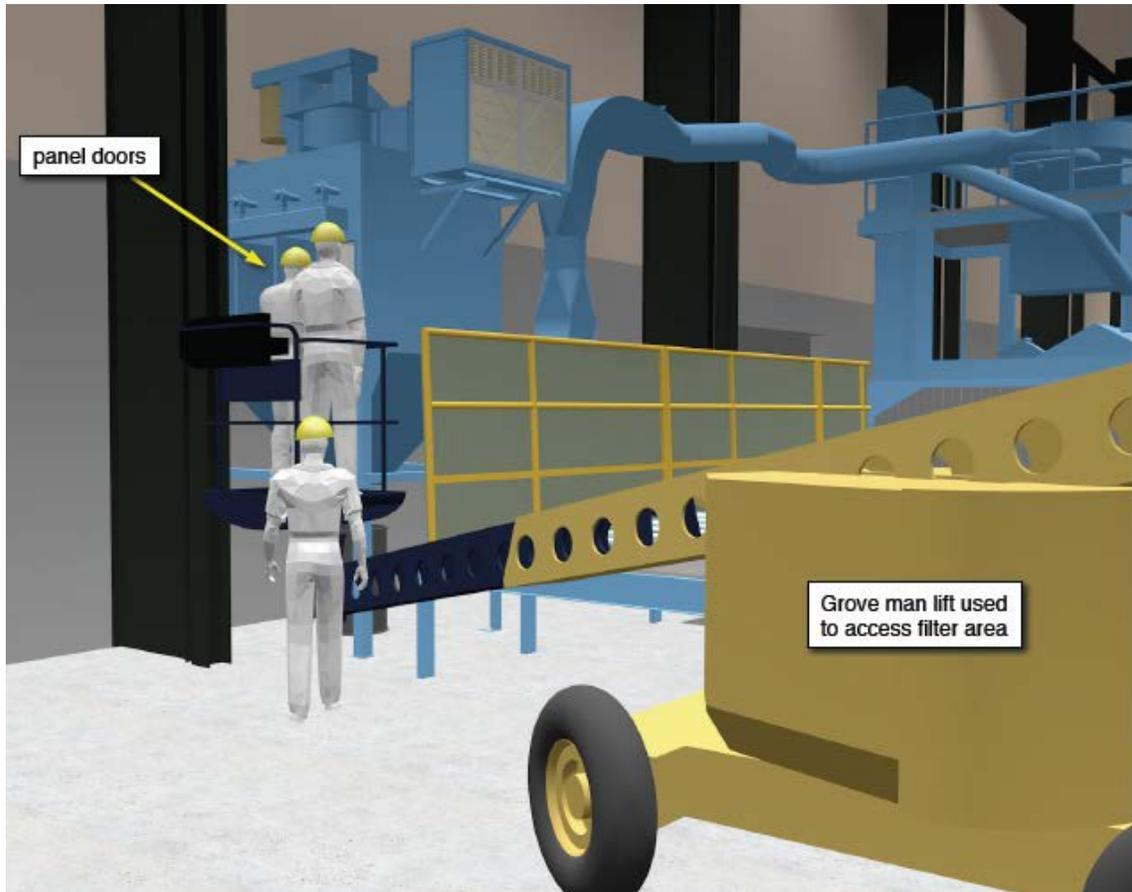
Worrell to use the Grove manlift to access and open the filter access doors on the collector. The position of the manlift and the work basket in which Mr. Gillespie and Mr. Worrell were situated is illustrated in Figure 2.

Figure 2. Position of Lift Work Basket and Personnel Next to Dust Collector

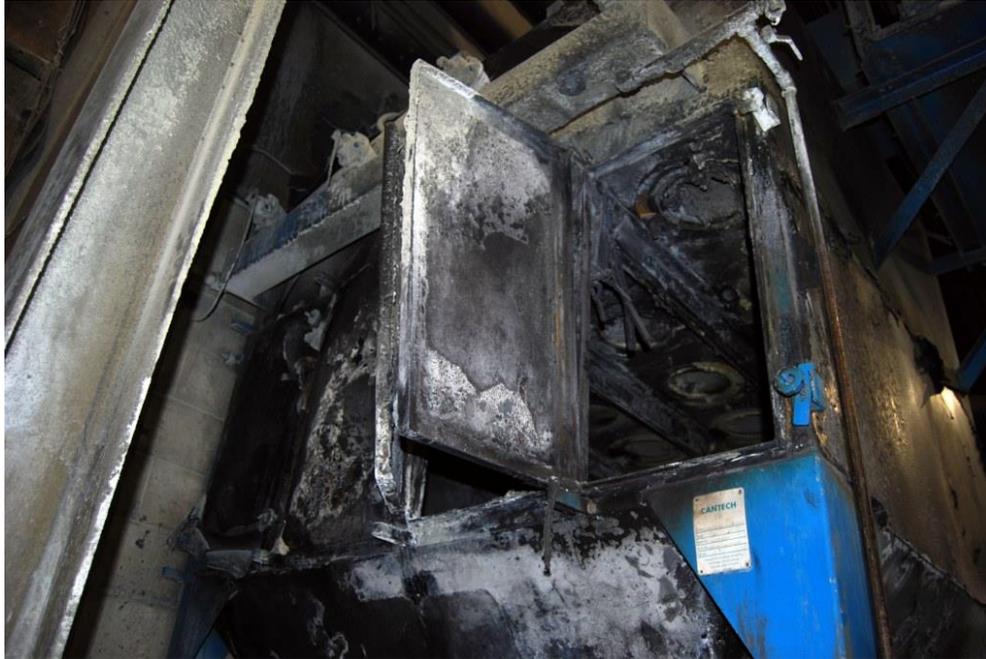
The fire in the collector continued to burn unabated for several minutes as Conn-Weld personnel frantically tried to move the Manlift and rescue Mr. Worrell, who was trapped in the Manlift for a longer period of time than Mr. Gillespie. Soon after the flame erupted, Mr. Gillespie says he crawled over the rail of the man lift basket and fell to the floor when residual flames burned his lanyard attaching him to the basket.<sup>16</sup> Eventually, Conn-Weld personnel and then responding firefighters extinguished the collector fire. The fire damaged filter compartment of the collector is shown in Figure 3. Most of the fire damage occurred during and after the vented deflagration since there was just smoke in the filter compartment before Mr. Gillespie attempted to extinguish the fire. Figure 4 is a broader view of the collector fire damage showing the thermal discoloration of the hopper and clean air chamber walls as well as the filter compartment.

Figure 3. Fire Damaged Collector Filter Compartment

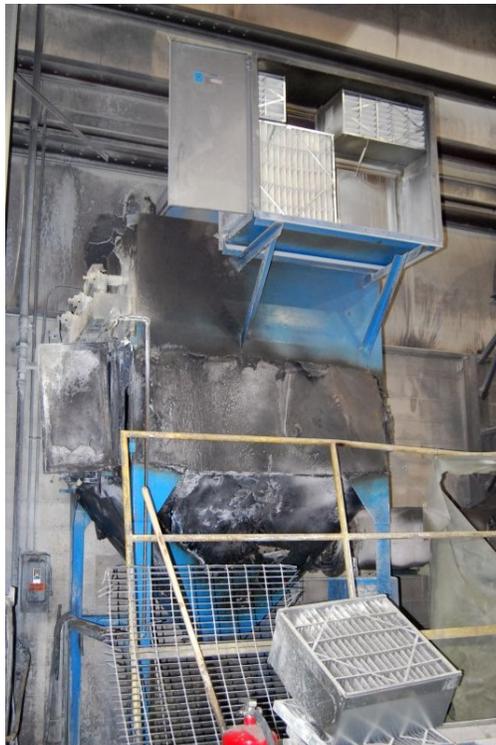
Figure 4. Dust collector after fire.

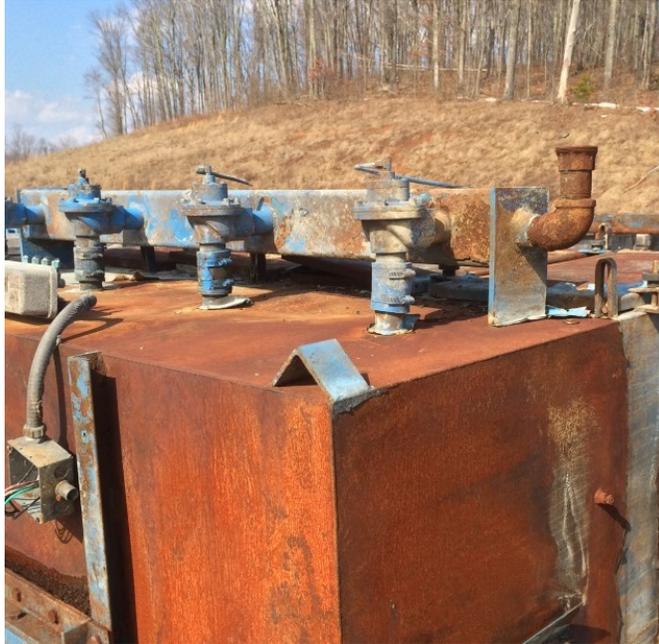
Discharge of compressed air could have been due to another use of the air wand by Mr. Gillespie immediately prior to the deflagration. He states that he reached into the open doorway at this time, but doesn't remember what he was trying to do. Another source of compressed air at the collector is the compressed air piping and tubing connected to the collector valves used to pulse the filters. However, in order for the compressed air to be discharged within the collector, one or more of the four diaphragm valves in the compressed air header on the collector exterior (see Figure 5) would have to be open. These valves open when they are triggered by a small (1/4 inch) pilot air tube connected to the solenoid valves<sup>18</sup> in a housing at the top of the collector. Since the electrical supply to the collector was shut off after the fire was discovered, the solenoid valves would not have been activated. It is not likely that the diaphragm valves would have opened by thermal degradation before the deflagration because there was no significant fire thermal exposure on the collector exterior until the deflagration. Therefore compressed air discharge via the installed compressed air piping and valves is less likely than possible use of the air wand.

Figure 5. Compressed air header and valves at top of collector.
