Rapperport Associates, Inc.
Engineering and Materials Consultants

Silk Air 185 Aircraft Accident Summary:

Rapperport Associates was engaged to develop a simulation of the final flight path based on flight recorder data, radar information and debris field Silk Air 185 wreckage scatter.

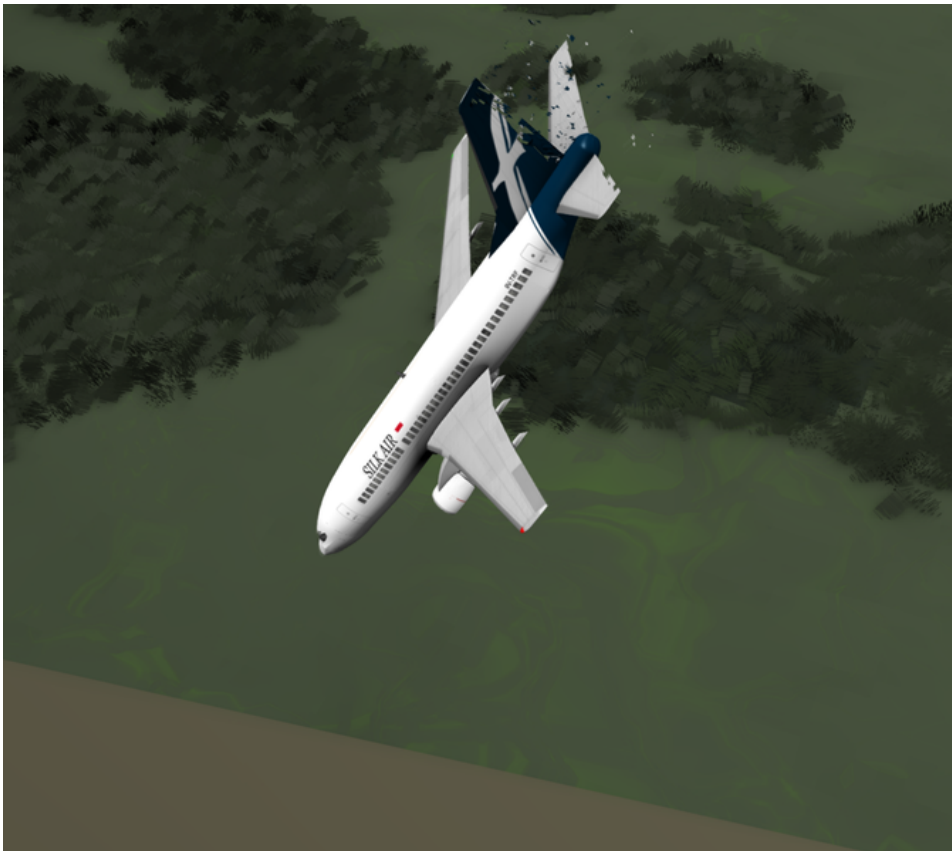
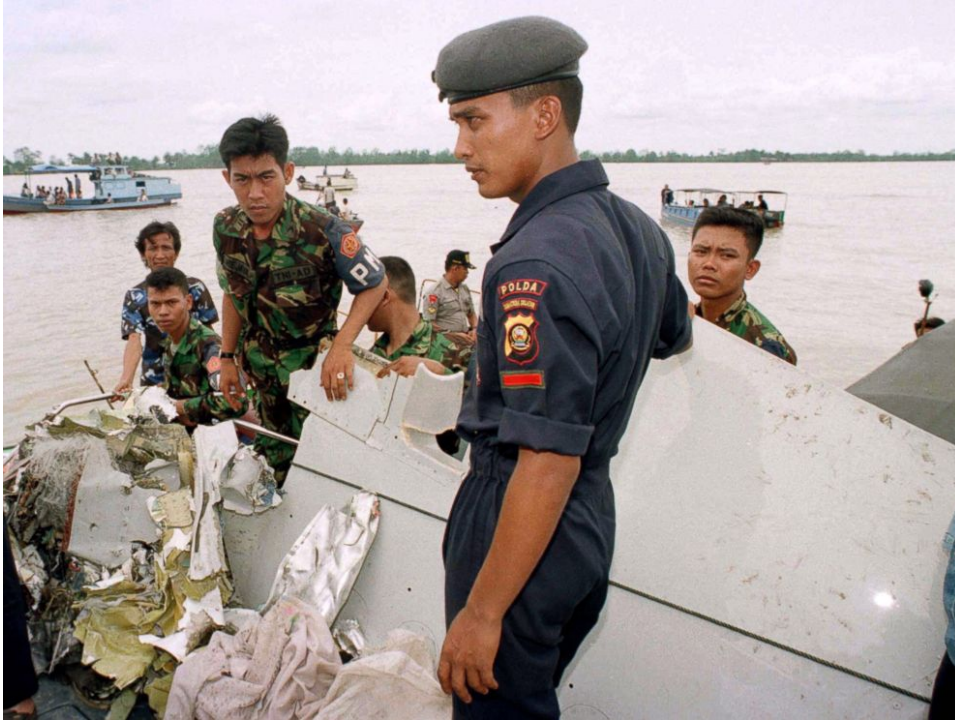
Photo gallery of Silk Air 185 crash:

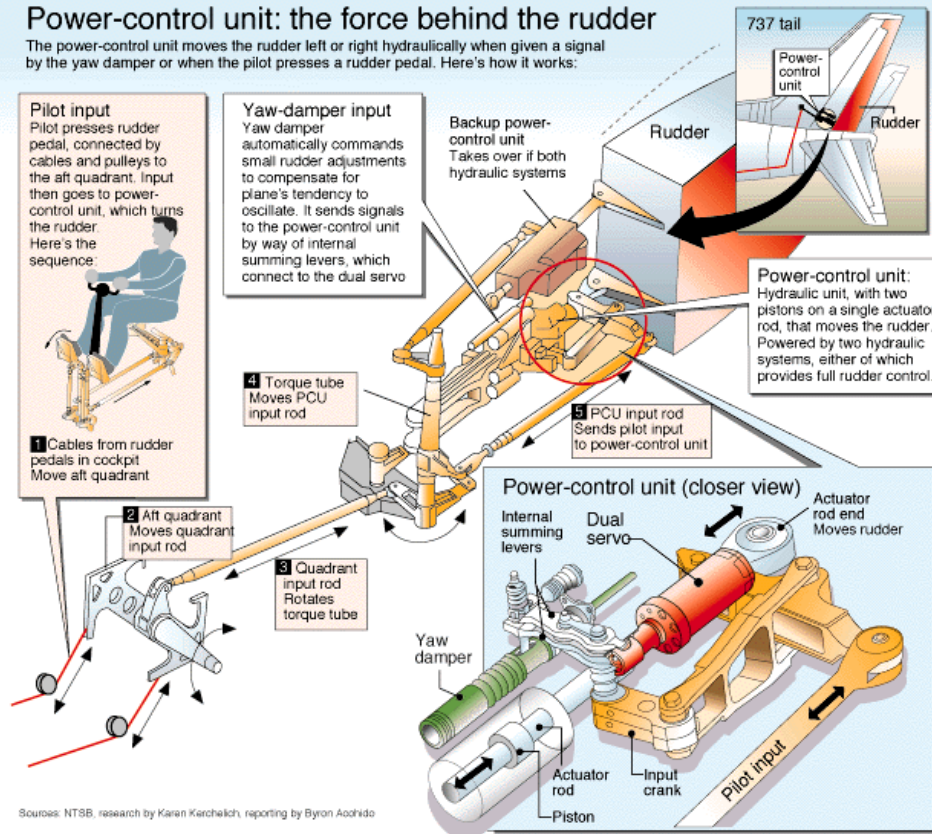
Power-control unit: the force behind the rudder

The power-control unit moves the rudder left or right hydraulically when given a signal by the yaw damper or when the pilot presses a rudder pedal. Here's how it works:
