Rapperport Associates, Inc.  
Engineering and Materials Consultants

Re: Helicopter crash

Rapperport Associates was retained to perform an investigation into the cause of a helicopter crash that occurred on May 4, 2004 in Brooklyn, NY. The helicopter was hovering at 1,000 to 1,200 feet, during a news gathering flight, when it experienced a loss of hydraulic system power. Another helicopter captured the accident sequence from its onboard video camera. The accident helicopter was observed entering a steep descent and quickly leveling off. A fairly constant, level attitude and heading were briefly maintained before the helicopter entered an unstable hover and began to rotate. It then descended and struck the roof parapet of a 4-story building, before it impacted and came to rest on the roof of an adjacent 2-story building.

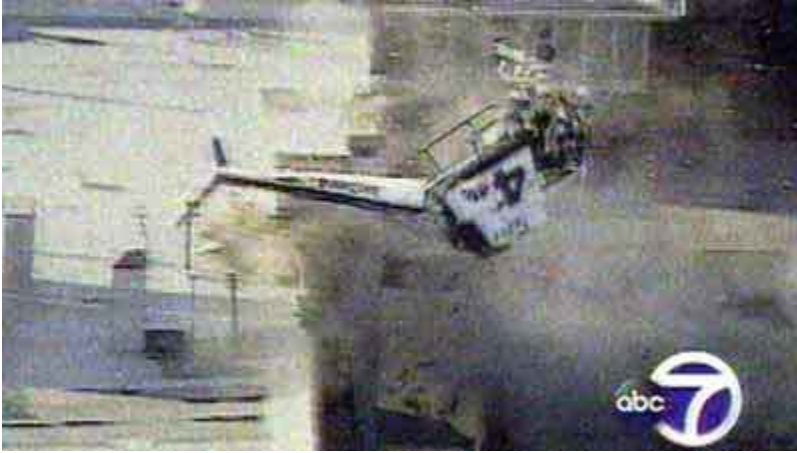
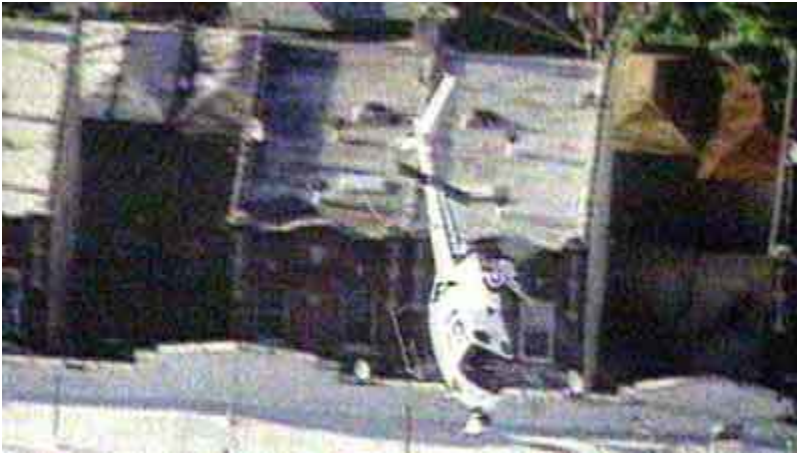
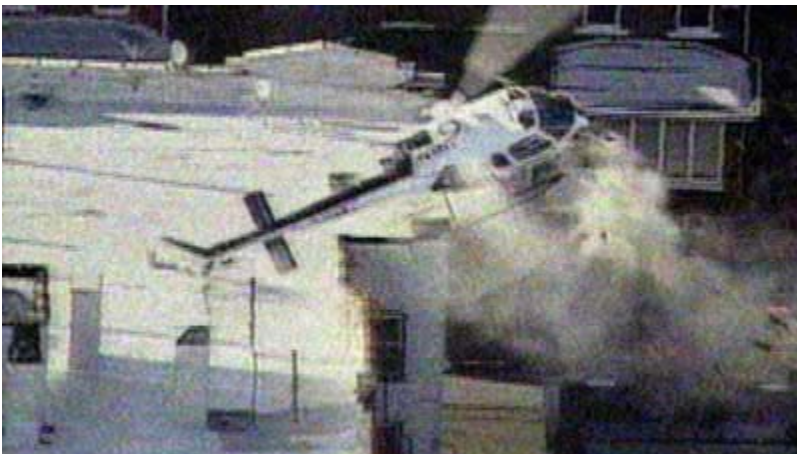
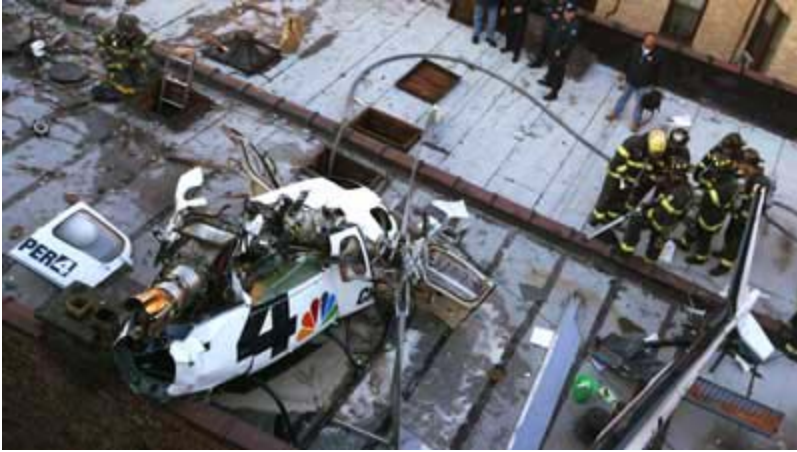
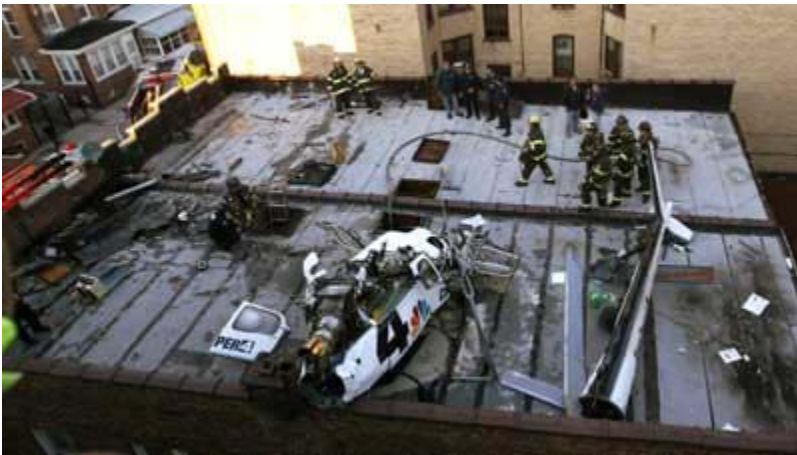
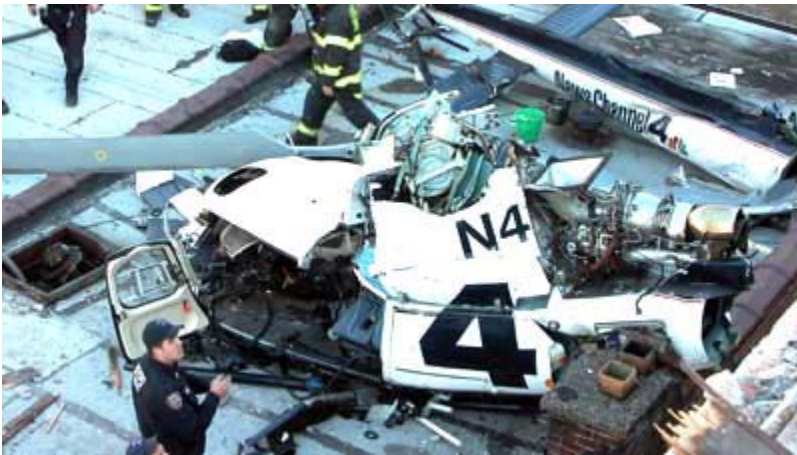
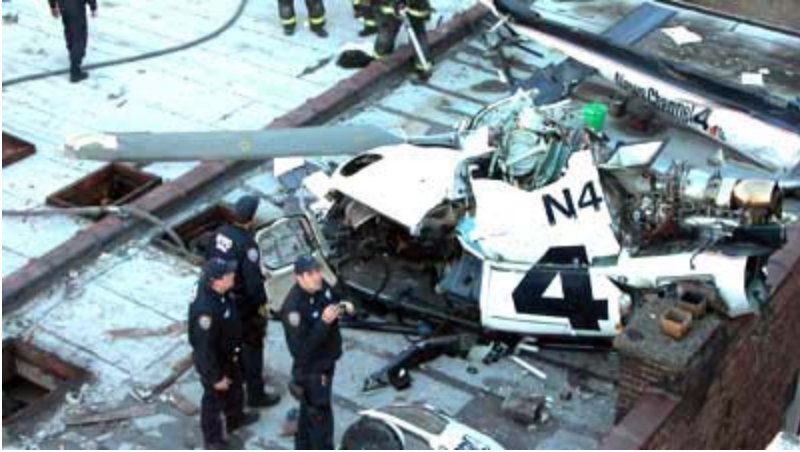
**Crash sequence:**

Our findings were that the initiating event was hydraulic failure due to failure of the hydraulic belt. The loss of hydraulic assist caused the helicopter to lose its equilibrium. The pilot was able to pull the Eurocopter out of the nosedive but as soon as he attempted to land, the Eurocopter entered an unstable hover condition. There was no indication that the pilot disengaged the hydraulic system as required subsequent to a loss of hydraulic pressure and his attempt to land on a rooftop and associated loss of forward speed rendered the helicopter uncontrollable causing it to roll left and crash.
