Rapperport Associates, Inc.
Engineering and Materials Consultants

Re: Selected case summaries

Boat winch:

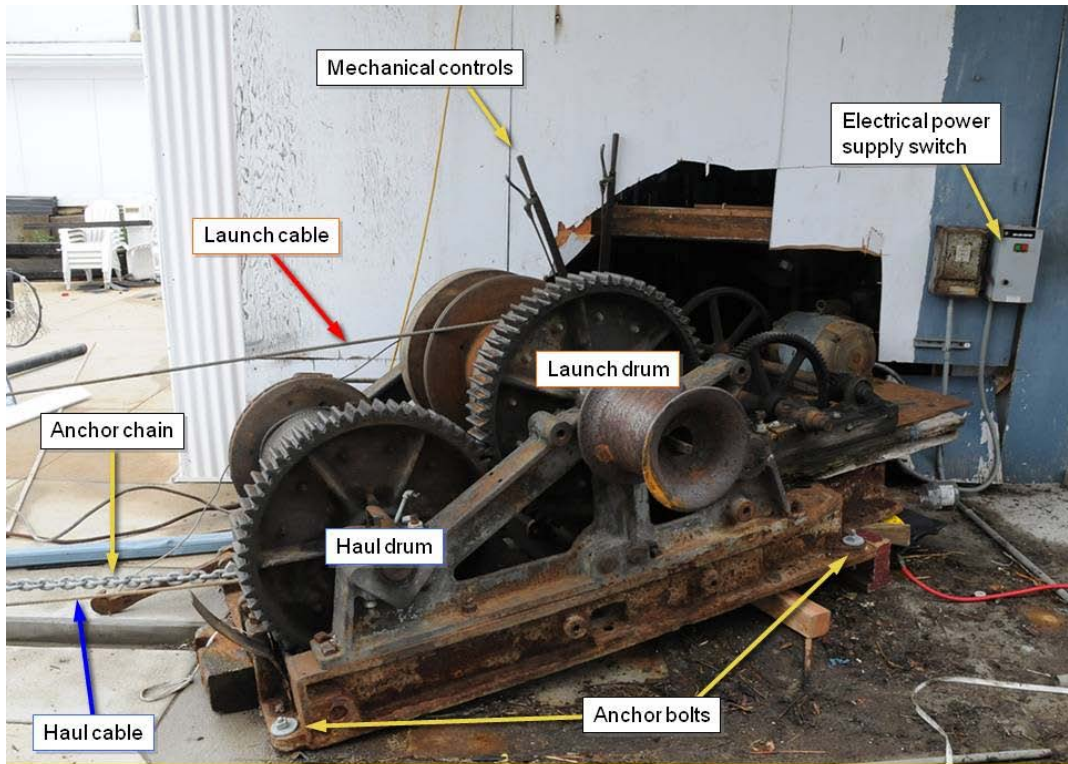
Boat Winch post-accident position

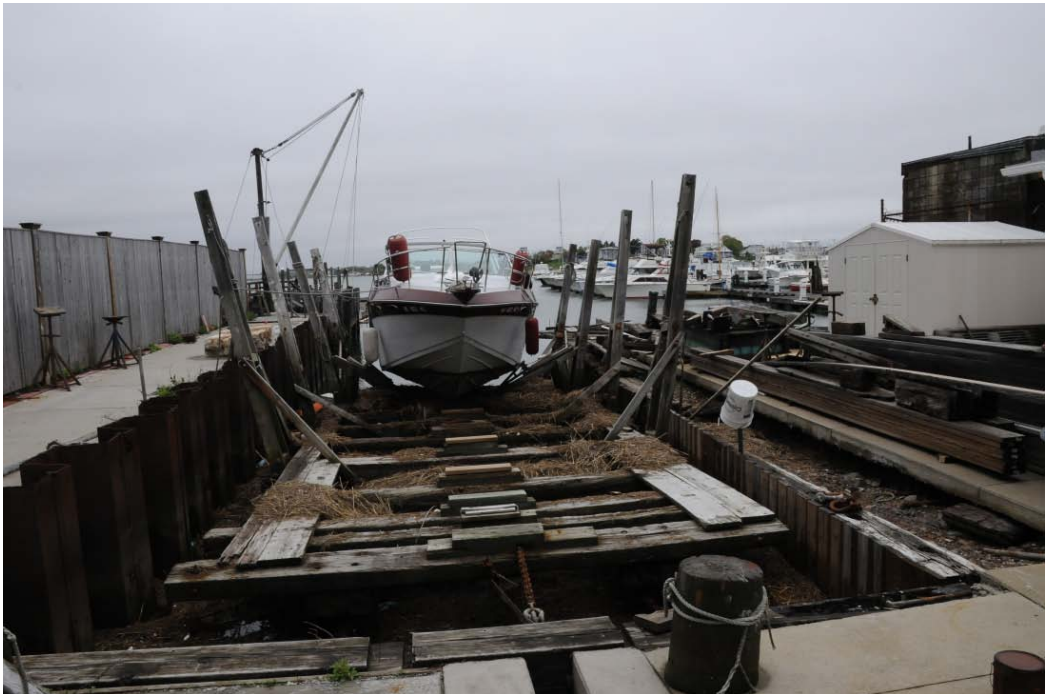
Boat launching

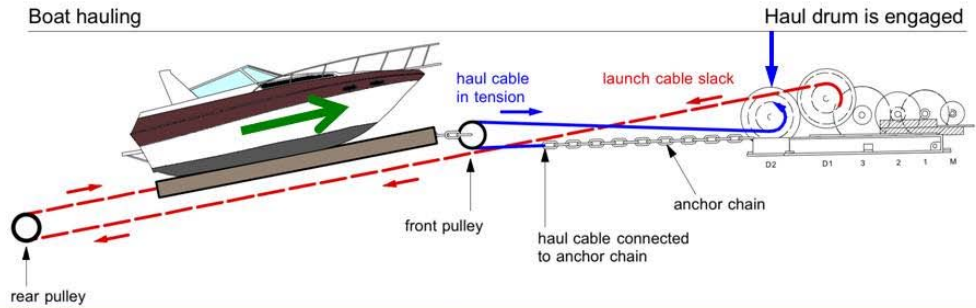
Boat Winch function schematic (safety chain disconnected from cradle)

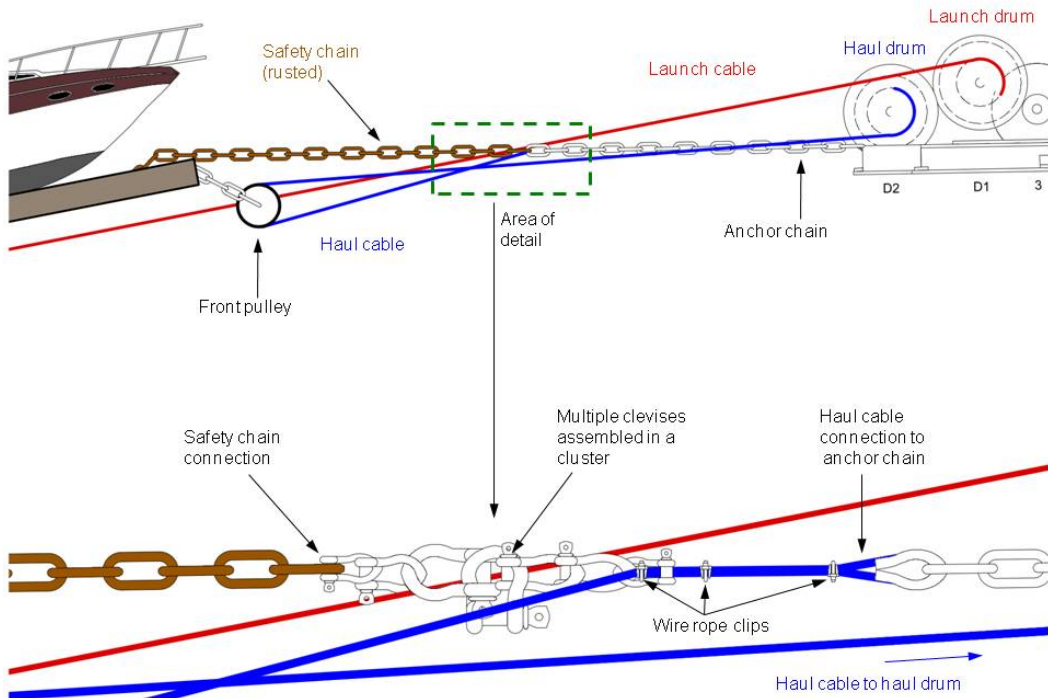
Safety chain and haul cable connections in detail

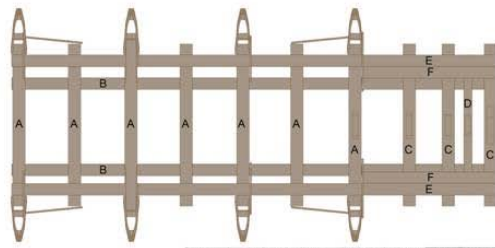
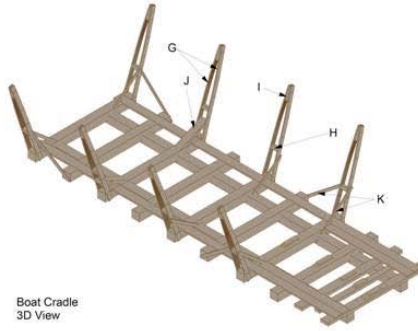
Note:
All dimensions are derived from visual estimates made from a scaled aerial view combined with visual estimates from photos of the accident site.

Visual estimate of cradle construction

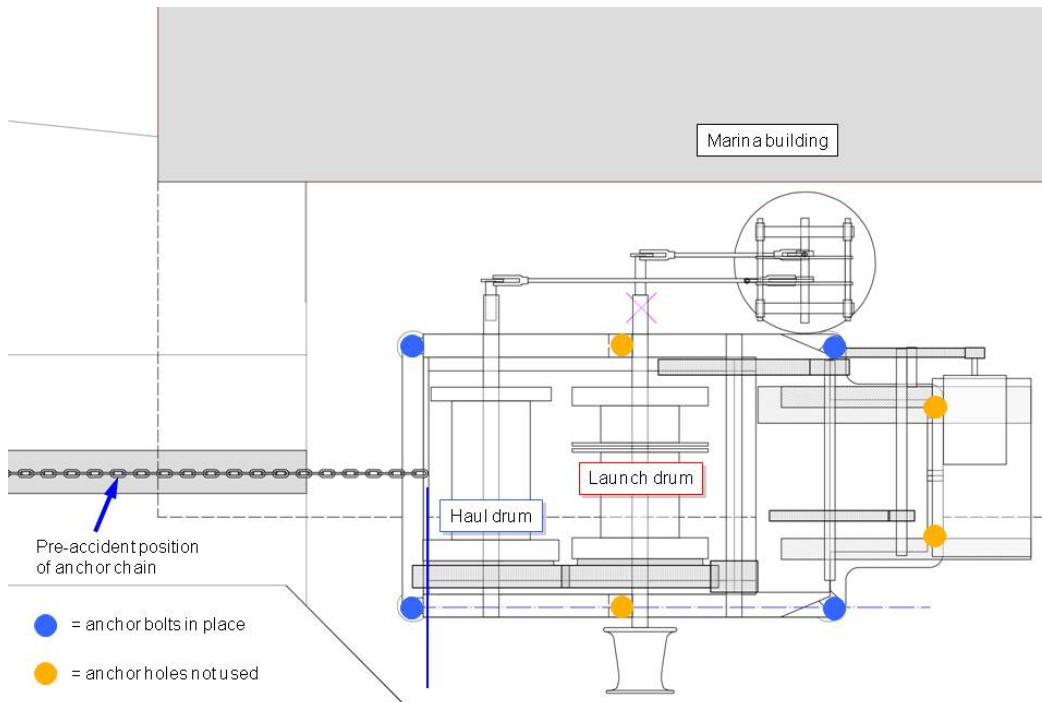
Boat winch top view before accident – anchor bolt number and positions

It was discovered that a safety chain was inadvertently left connected during launch which resulted in high winch loads. Further investigation revealed that there were several serious deficiencies with regard to the anchor bolt placement and that had the winch anchoring system been properly designed and constructed, the anchor bolts would have withstood the cable forces and prevented the winch from coming lose and killing the operator.
